THREE RIVERS INSPECTION & ENGINEERING, INC.  
INSPECTION REPORT

Address Here

January 20, 2004

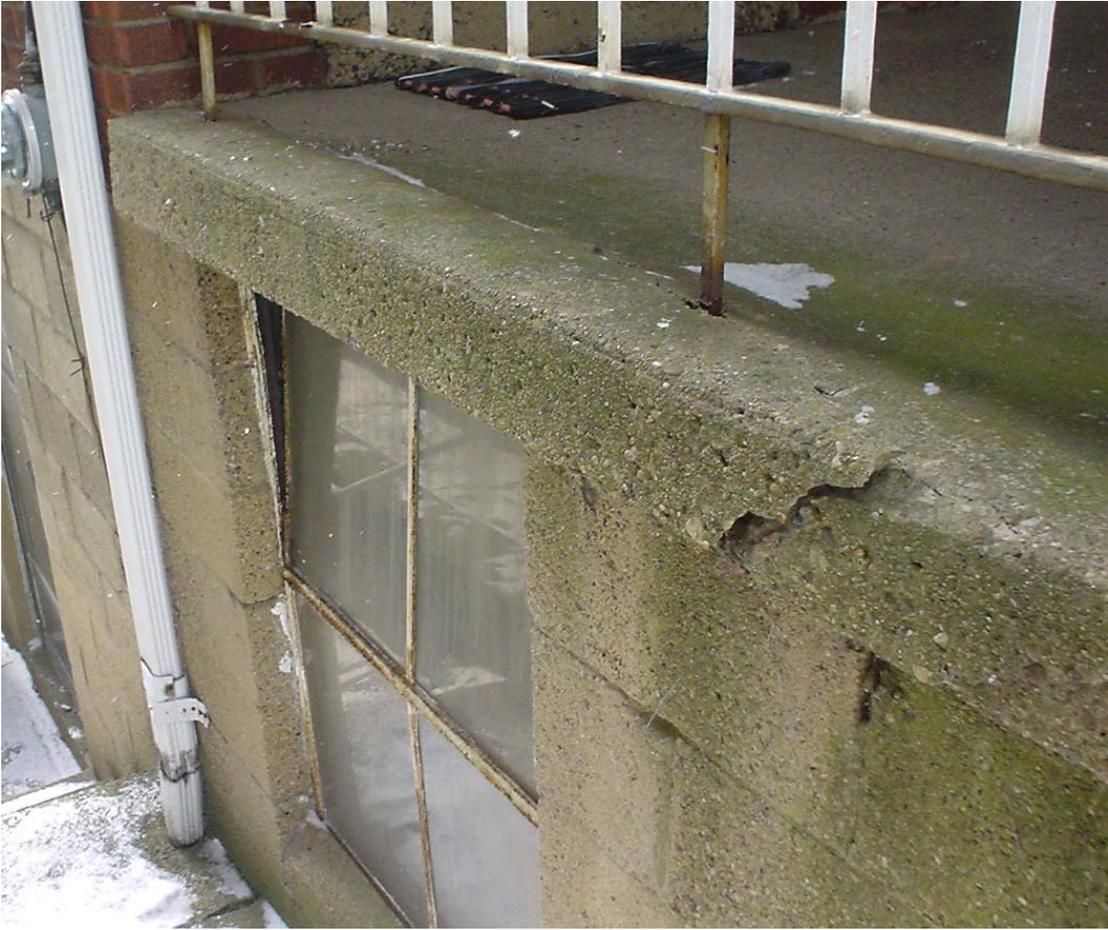
The window opening in the wall below the left edge of the front porch has a steel lintel that spans across the top edge. Rust has accumulated above the steel lintel. The accumulated rust has pushed up on the concrete slab porch floor. This upward push has cracked off a piece of concrete in the area above the window. The upward push has also lifted the entire slab by a fraction of an inch above the foundation walls. See the photos below.

Cracked concrete above window.

Suggested repair: Remove the window, lintel and loose concrete. Install a new lintel. Pour a new section of concrete. Install a new window and caulk around the perimeter between the bottom of the concrete slab and the foundation wall.

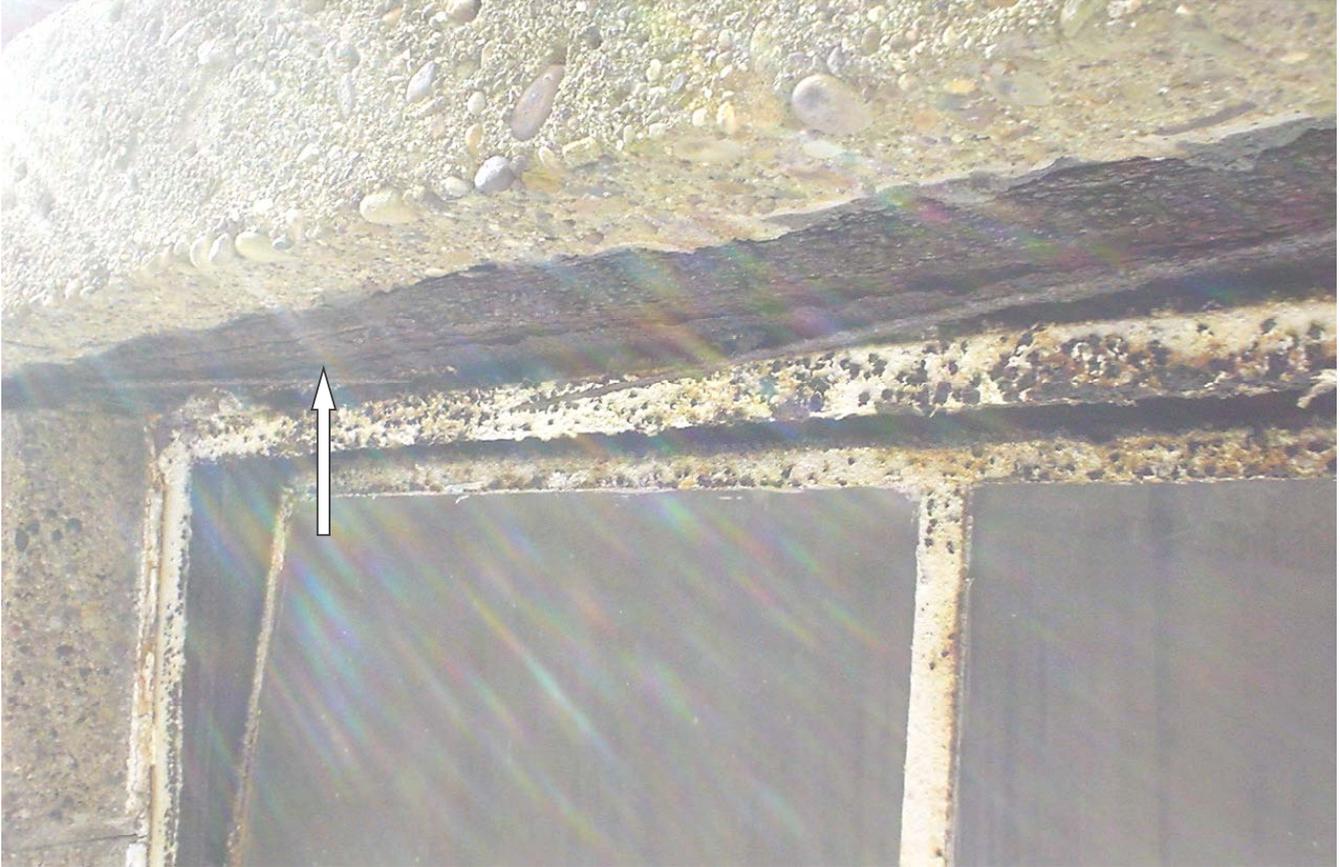
Remnants of rusted steel lintel that pushed upward on concrete and down on window.

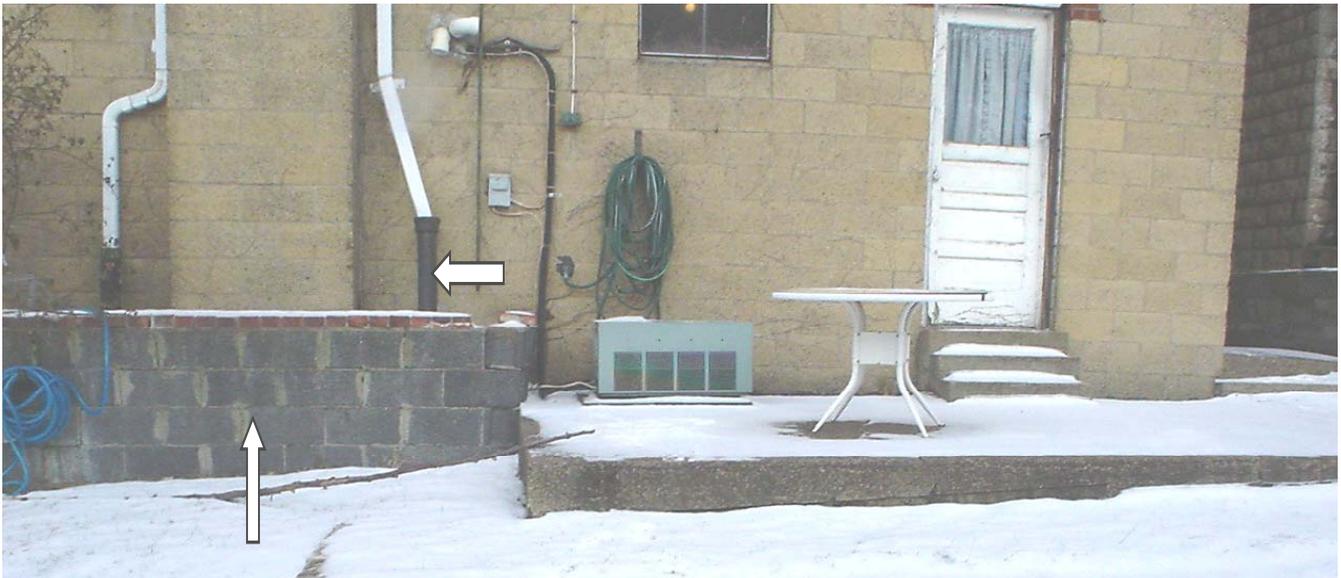
The concrete block retaining wall around the back chimney is starting to collapse. It is suggested that this wall be removed before it falls. See the photo below.

The underground drainpipe for the downspout at the back of the house was filled with ice. It appears that the underground drainpipe is clogged. Clearing the clog could be as simple as snaking the drainpipe or the clog could be a result of a permanently damaged underground drainpipe. Repair as necessary to avoid having the downspout water overflow onto the ground adjacent to the house foundation wall. Note that the overflowing water has most likely contributed to the deterioration in the retaining wall that surrounds the downspout.

Retaining wall and clogged downspout.
