Re: 123 Main Street, Anytown, PA

On September 14, 2021, Three Rivers assessed the structural soundness of the back foundation wall at the subject property.

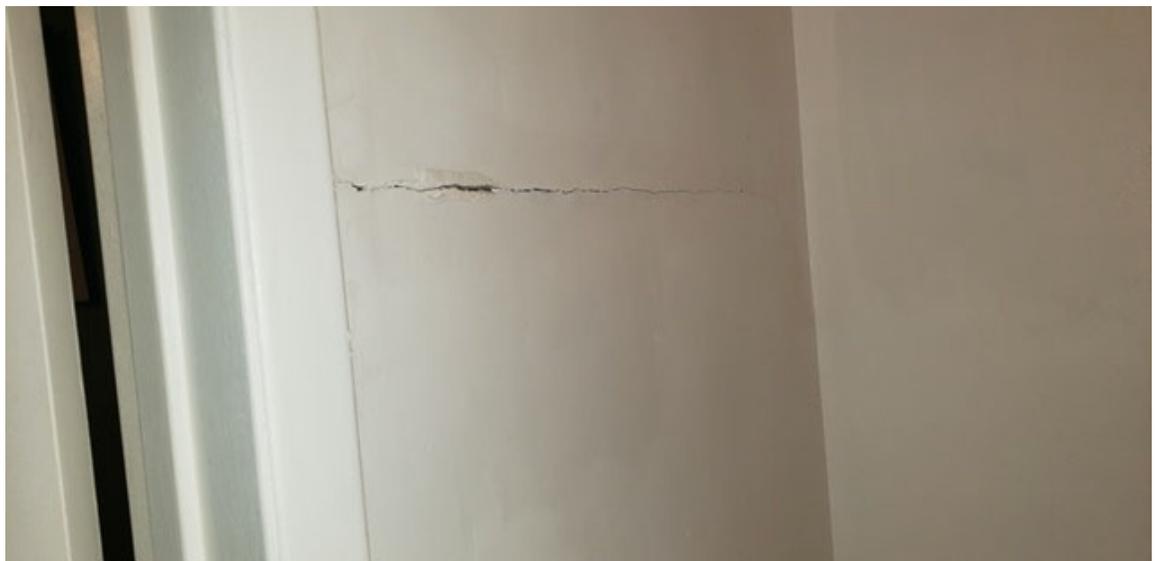
The door into the bathroom couldn't be closed because the inward displacement of the foundation wall narrowed the door opening width.

The drywall on the left wall in the bathroom developed a horizontal split in response to inward foundation wall displacement in that area.

The paneling installed on the back foundation wall in the family room has split at the top edge.

Have a qualified wall anchor installation contractor in to install eight wall anchors across the entire width of the house back foundation wall.
